9th International Conference "Bridges in Danube Basin 2016", BDB 2016

## Highway Viaduct Renovation

Ivanka Topurova<sup>a</sup>, Petar Nikolov<sup>b</sup>, Kostadin Topurov<sup>c\*</sup><sup>a,b,c</sup>*University of Architecture, Civil Engineering and Geodesy, Hristo Smirnenski 1, Sofia 1000, Bulgaria*

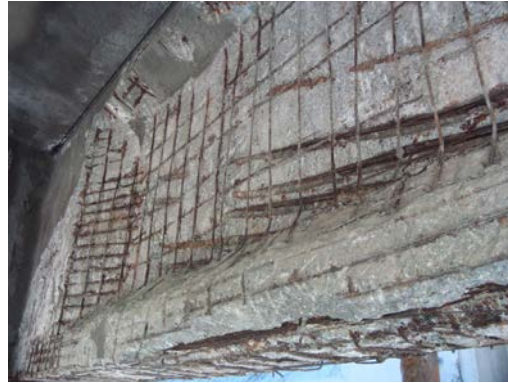
Fig. 4 View of the post-tensioned cables

The removal of the shot concrete during the construction phase has shown that the beams really are in severe condition. This was especially valid for some beams, where the inlets of the draining system were allocated, thus around 9 post-tensioned cables out of 19 were damaged. The steel sheet ducts, covered with lead, are fully destroyed by corrosion and more than 50% of the wires in the cables are affected by the corrosion as well.

The web concrete (approximately 50% of its thickness), stirrups and longitudinal reinforcement are destroyed by corrosion. The steel roller bearings need to be cleaned of the rust and grease, however the reinforcing elastomer bearings are in good condition.
